# Operating Experience Weekly Summary 97-51

*December 12 through December 18, 1997*

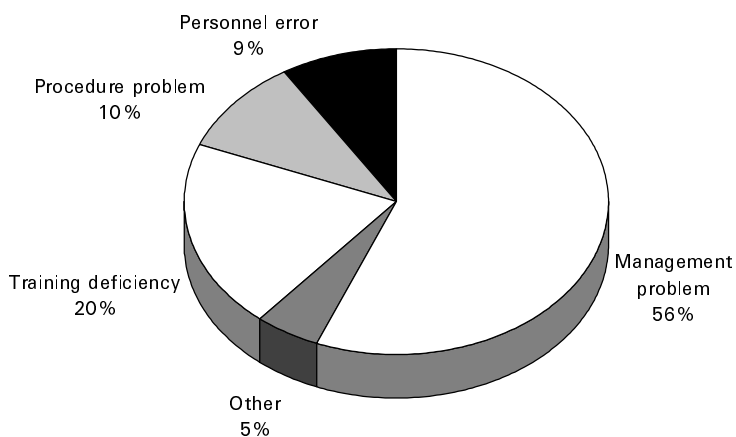
Figure 2-1. Root Causes for Training Deficiencies<sup>1</sup>

OEAF engineers searched the ORPS database for training deficiencies across the DOE complex and found 291 occurrences. Figure 2-1 shows that facility managers reported management problems as the root cause for 56 percent of the occurrences. Further review shows that they reported 35 percent of the management problems as inadequate administrative control and 26 percent as policy not adequately defined, disseminated, or enforced.
